### TI-1082

#### HORIZONTAL ADJUSTMENT OF GAP BETWEEN DRUM RIM AND FRONT PANEL ON TD30, TD50 AND TD75 TUMBLE DRYERS.

**MACHINES AFFECTED:** All TD30, TD50 and TD75 dryers

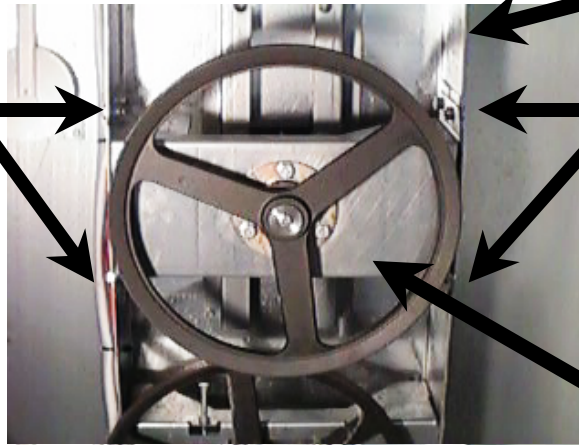
Figure 2 - Loosen  
**FOUR BOLTS** on ONE  
SIDE or the other!!

Loosen four bolts at this end of bearing bridge if gap at front is smaller on the RIGHT side of door opening when viewed from the front

Loosen four bolts at this end of bearing bridge if gap at front is smaller on the LEFT side of door opening when viewed from the front

between the drum and front panel flange. That is, if the undersized gap is at the left side of the dryer door opening when you are looking into the drum from the front, then go to the rear of the dryer and loosen the four bolts at the right end of the bearing bridge (as seen when you are looking at the bridge from behind the dryer).
