TI 1101 – TD dryer belt tension

MACHINES AFFECTED: TD30, TD50, TD75, all versions produced from 6/2002 through 1/2003.

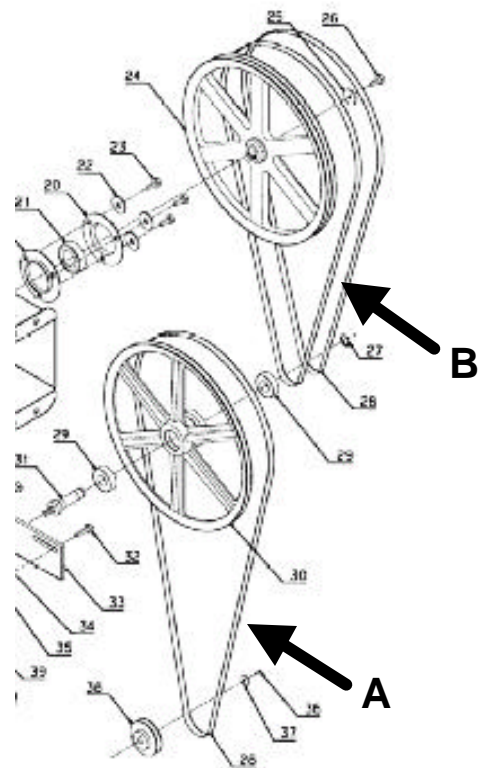
On TD30, TD50 and TD75 dryers produced between June, 2002 and January 2003, it has been determined that the drive belts may have been over tightened during assembly of some machines. On the next service visit, it is recommended that the drive belt tension be inspected, and adjusted, as necessary.

Note that “A” is the point on the free length of the belt, half way between the motor pulley and the idler pulley. “B” is the point on the free length of the belt(s), half way between the idler pulley and the drum pulley.

The table below provides correct tension data for the drive belts on these models. Note that the tension may be checked by force/deflection measurement or by measuring the response frequency of the belt when plucked.
