TI 1098 - TD3030 locks

MACHINES AFFECTED: TD3030 from S/N 23300/002677 to S/N 23300/006352, inclusive.

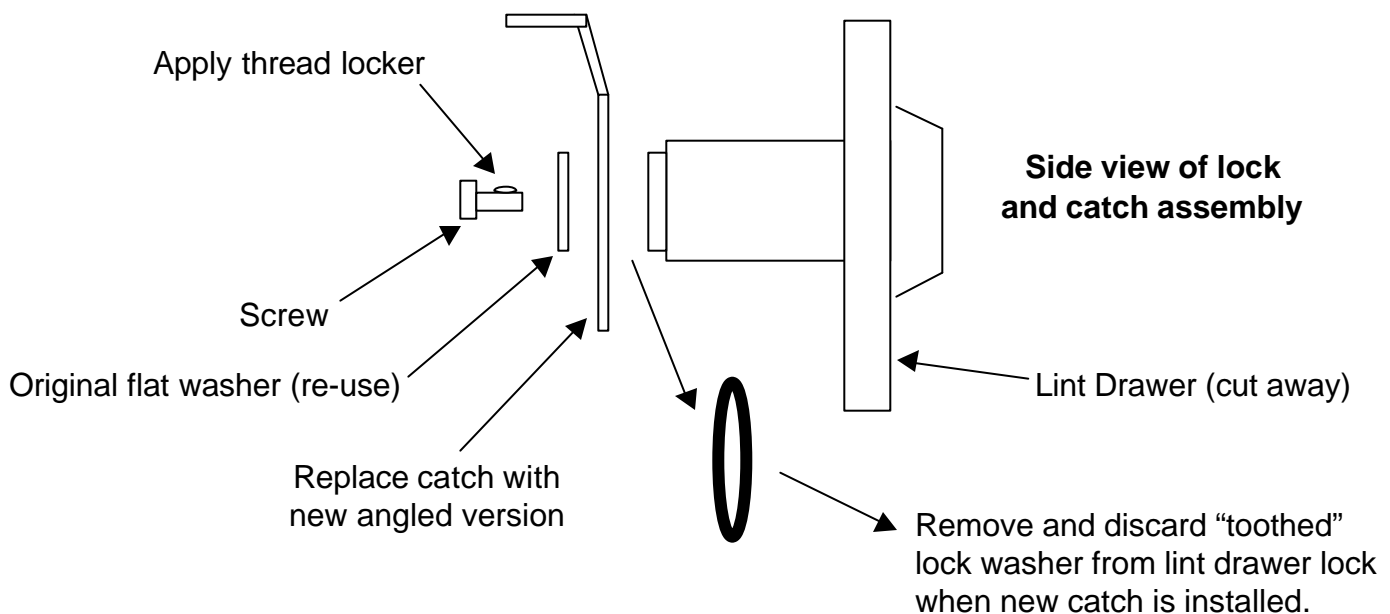
On TD3030 dryers from serial number 23300/002677 to 23300/006352, there is a tendency for the lock-catch retaining screw to loosen and fall out of the lint drawer (and possibly the control-panel) lock. When this occurs, the tumbler assembly may fall out of the front of the lock cylinder, and come apart, requiring replacement.

At the next service visit, it is recommended that the catch-retaining screw be removed, and re-installed using a small amount of thread-locking compound on the screw threads (Loctite 222 or equivalent). Use care to prevent the tumbler from falling out of the lock cylinder while the screw is removed.

If necessary, replace the complete lock assembly and catch, re-assembling the unit as shown. Note that the replacement catch for the lint drawer has a slight bend in it, and that the toothed lockwasher between the catch and the lock cylinder is to be removed from the assembly when the new catch is installed.

Control door lock with keys: 487 194652

Control door catch: 487 175628

Lint drawer lock with keys: 487 194653

Lint drawer catch: 487 175633
