TI 1100 - TD3030 Lint drawer noise

MACHINES AFFECTED: TD3030

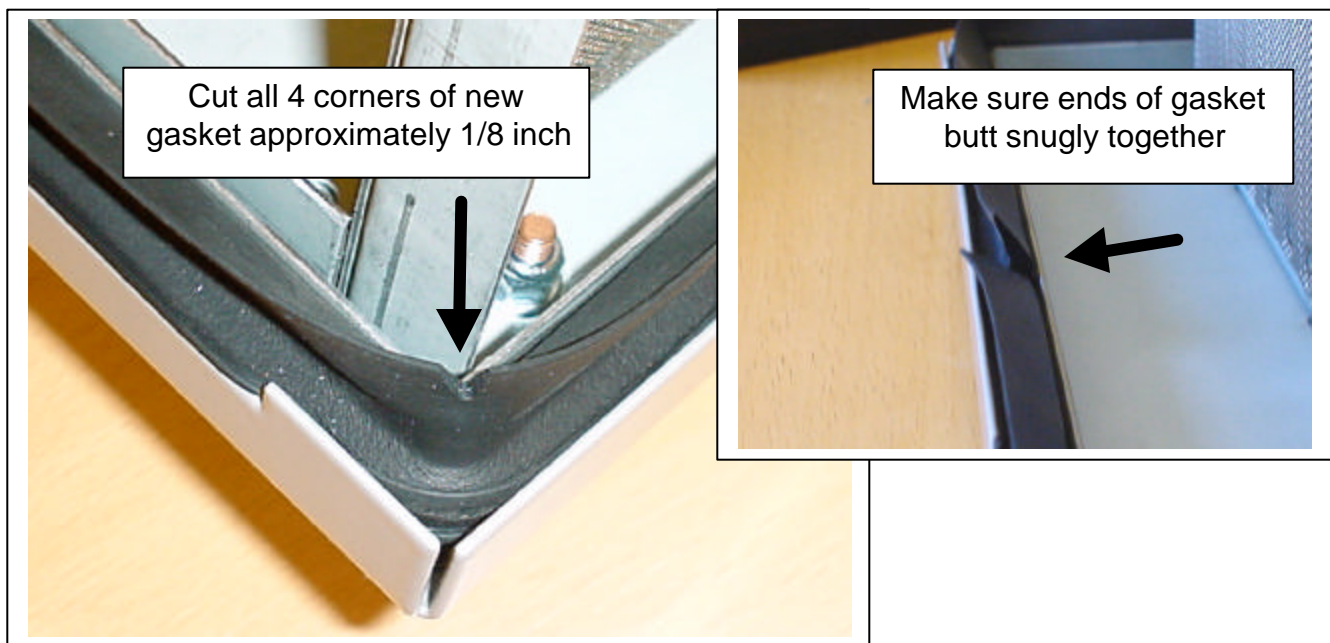
On some TD3030 dryers, the lint drawer gasket corners were cut too deeply during manufacturing. This can allow air to pass through the resulting gaps in the gasket, creating a “whistling” noise.

To correct this problem, replace the gasket with a new one (Wascomat part number 487 151079). Use a diagonal cutter or razor blade to cut the 4 corners of the new gasket, as shown.

Also, be sure that the ends of the replacement gasket fit snugly together. The seam should be located in the middle of the lower gasket track on the drawer, as shown below-right.
