TECHNICAL INFORMATION

TI-1060A

INSTRUCTIONS FOR INTERLOCKING EXTRACT RELAY COIL WITH WASH RELAY ON "W" 75, 105, 125 AND 185 WASHERS

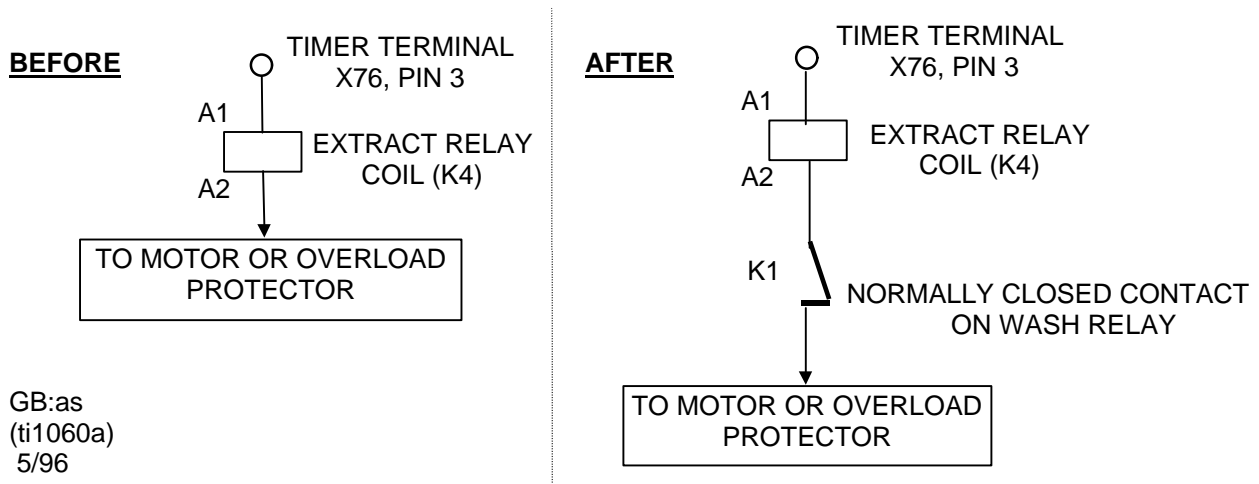
EXTRACT RELAY CIRCUIT MODIFICATION

This document provides instructions for adding an interlock contact to the extract relay coil of W series washers. The modification insures that the extract relay coil is always de-energized during wash action.

1. **DISCONNECT ELECTRICAL POWER FROM THE MACHINE.**
2. Remove the machine's top panel.
3. Identify that relay whose A1 coil terminal is connected to timer terminal X76, pin 3. This is the extract relay.
4. Remove the wire which is connected to the A2 coil terminal of this relay. Connect this wire to one side of a vacant normally-closed contact on the wash relay. If a normally-closed auxiliary contact must be added to the wash relay, to make this connection, use Wascomat Part No. 510292.
5. Connect the opposite side of the normally-closed contact on the wash relay back to the now vacant A2 coil terminal of the extract relay.
6. Replace the top panel of the machine
7. Restore power and test the machine.
