TI 1095 – Displaced drain solenoid tube

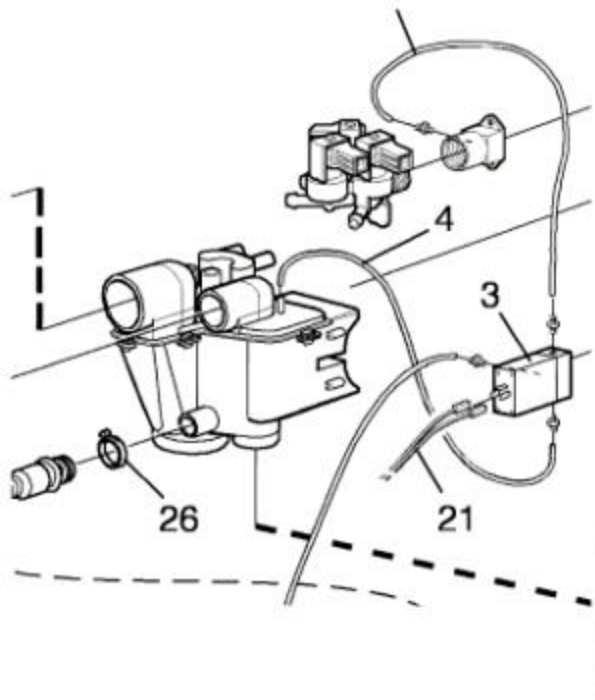
On Generation 6 washers equipped with water-operated drain valves, it is possible for the plastic tubing between the “R” port of the drain solenoid pilot valve and the siphon breaker (item 4 in the accompanying illustration) to come out of its siphon breaker fitting. This may expose components inside the machine to water, causing malfunctions.

At the next service opportunity, remove this tube from the siphon breaker fitting, coat the outside of the tube with silicone sealant / adhesive, and firmly push the tube back into the siphon breaker fitting. Test the drain valve operation to insure that the tube is not obstructed by the silicone sealant / adhesive.
