TECHNICAL INFORMATION

MACHINES AFFECTED: Dryer models: TD30, TD50, TD75 (gas heated only).

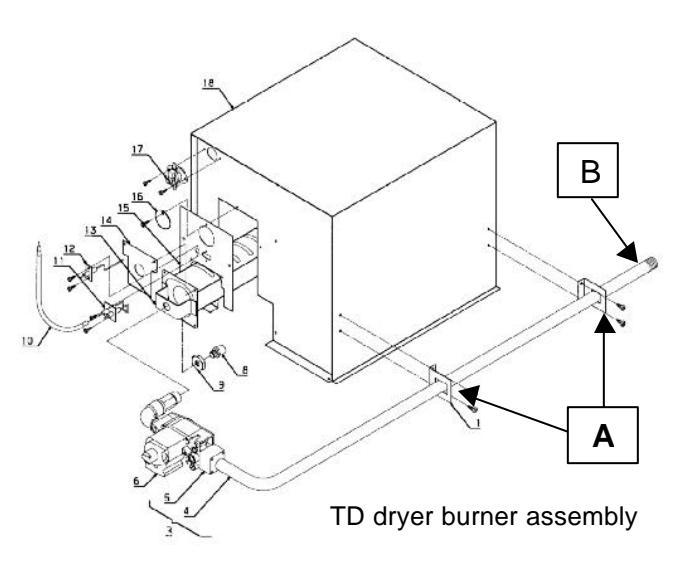
On the above referenced models, it is possible for the gas-pipe support brackets on the right side of the burner compartment (viewed from the front) to rub against the gas pipe, causing a wear groove to develop in the pipe due to normal machine vibration.

Dealers and owners are instructed to conduct an immediate visual inspection at two points "A" (where the gas pipe is supported by the two brackets), and point "B" (where the gas pipe passes through the back panel of the dryer).

Note that some small scratches and / or wear marks on the gas pipe are normal.

If grooves are found on the gas pipe, turn off the gas supply and the electrical service to the machine, placing it out of service, and contact Wascomat's Technical Support department at 516-371-0700 for further instructions.

A corrective action Technical Instruction bulletin will be sent to you, providing instructions to permanently correct this item.
